Lower Passaic River Restoration Project

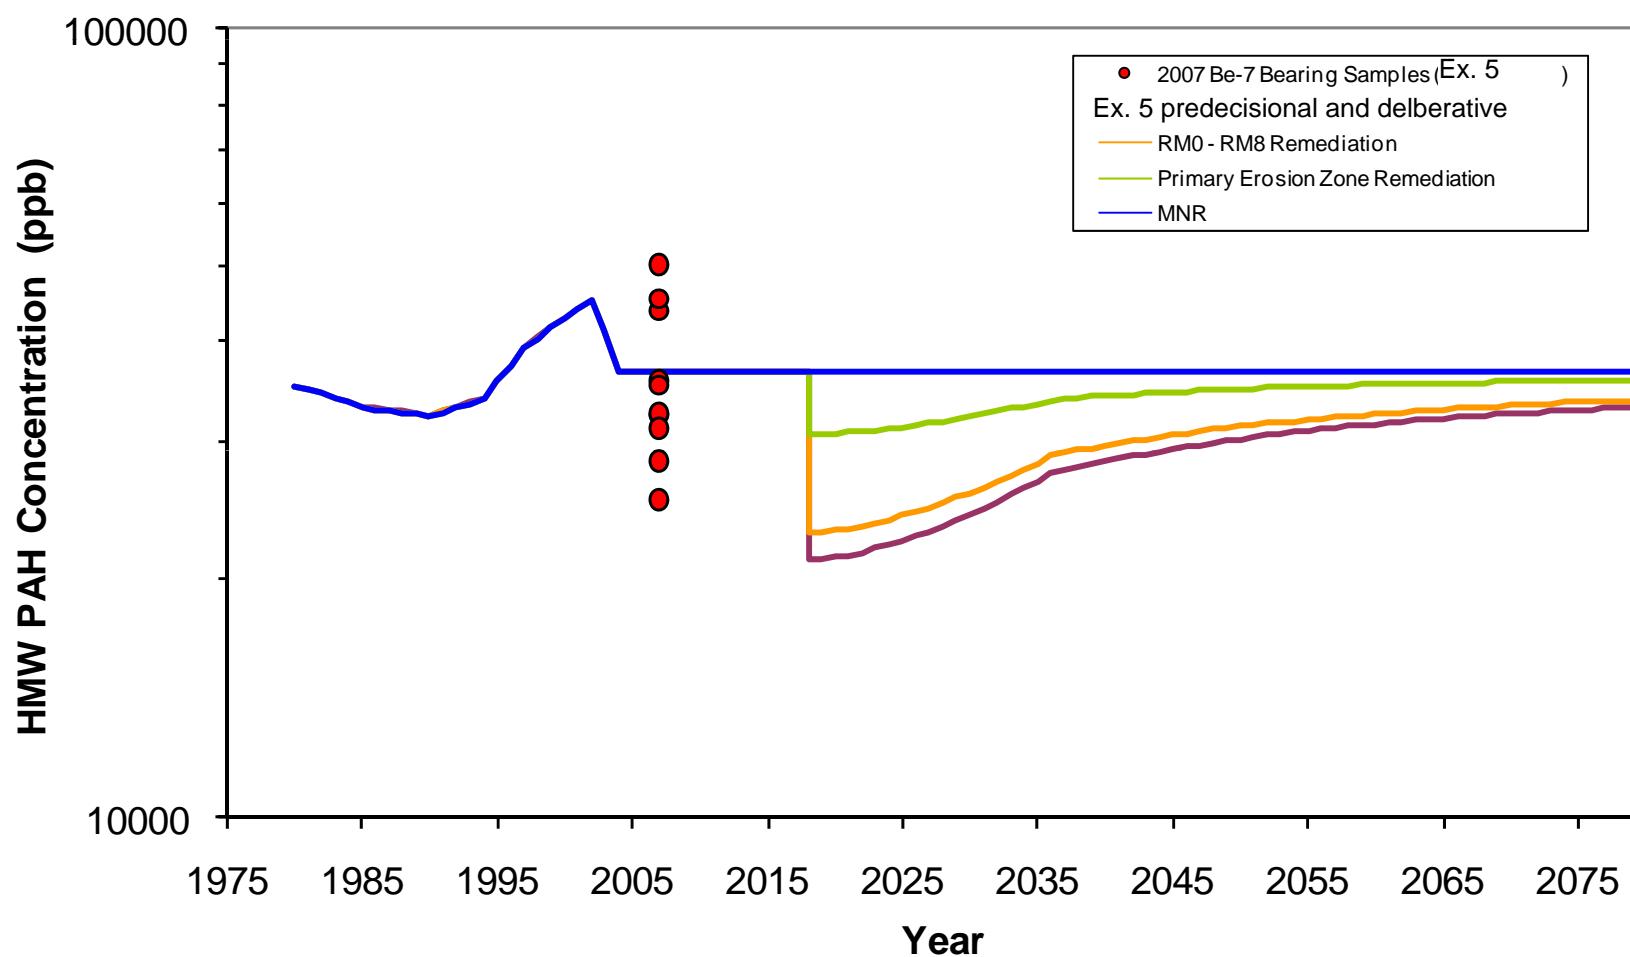
Figure 20-27

HMW PAH
Comparison of Estimated Trajectories for Remediation Options for Be-7
Bearing Sediment Ex. 5
Lower Passaic River Restoration Project

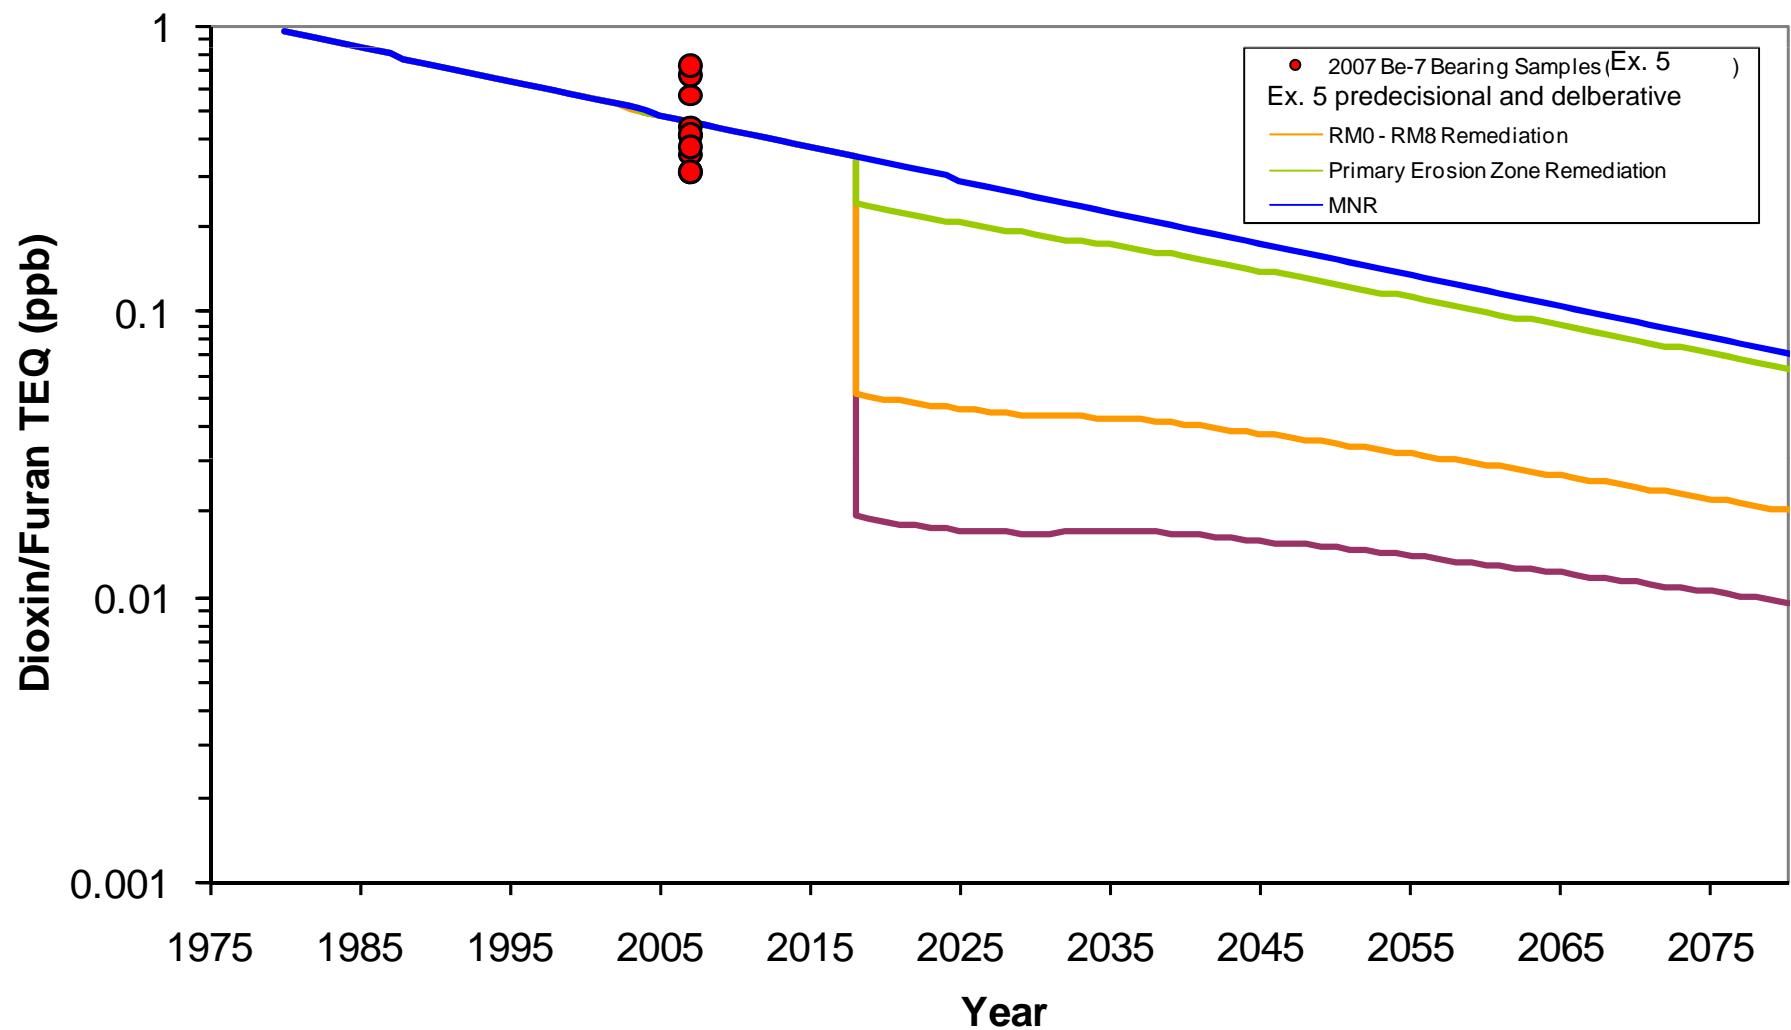
Figure 20-28

Dioxin/Furan TEQ (Fish)
Comparison of Estimated Trajectories for Remediation Options for Be-7
Bearing Sediment (Ex. 5)
Lower Passaic River Restoration Project

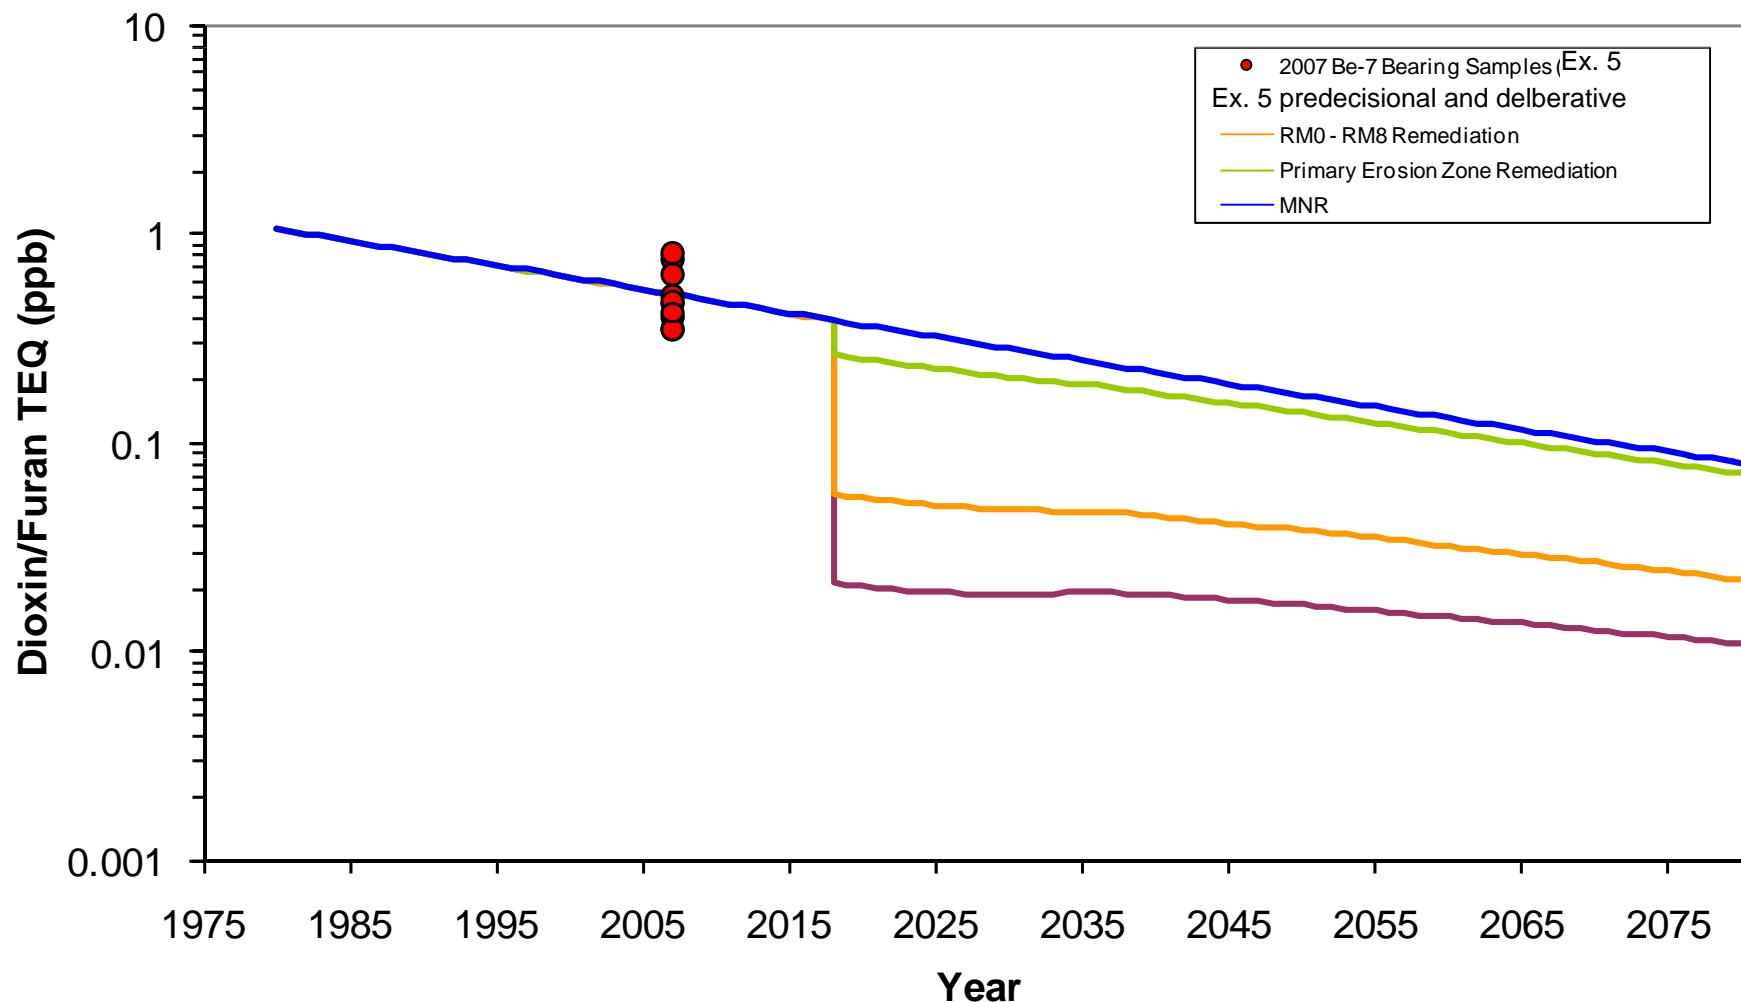
Figure 20-29

Dioxin/Furan TEQ (Bird)
Comparison of Estimated Trajectories for Remediation Options for Be-7
Bearing Sediment (Ex. 5)
Lower Passaic River Restoration Project

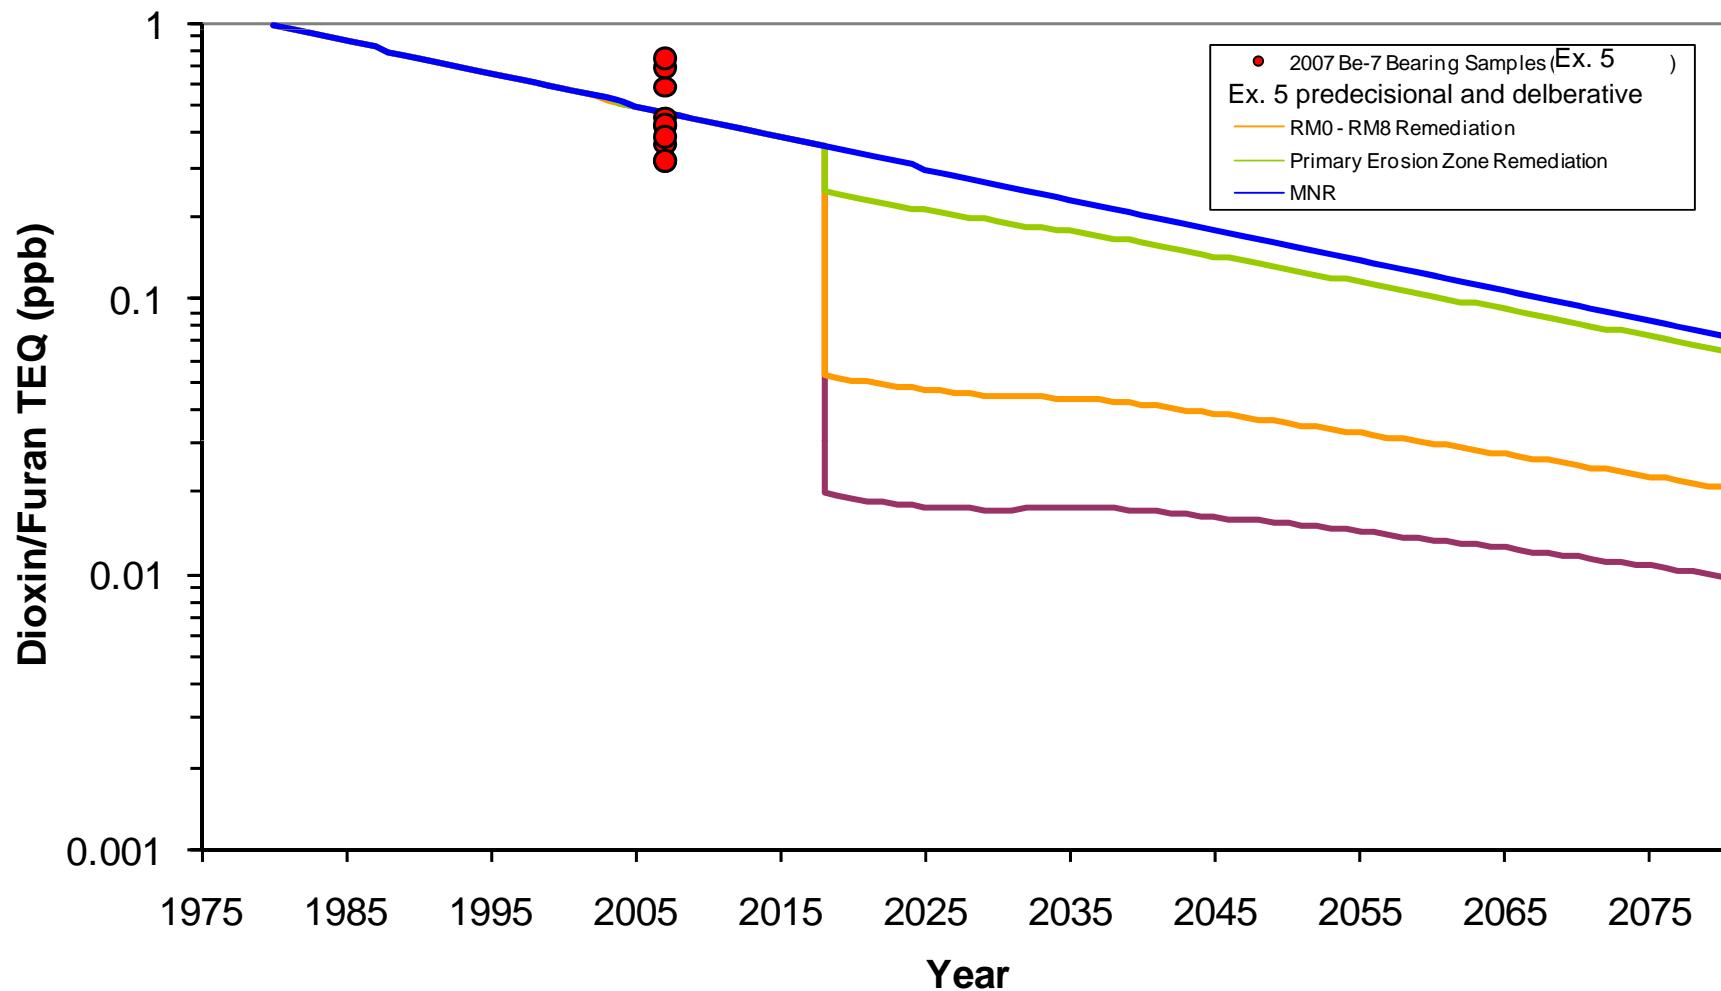
Figure 20-30

Dioxin/Furan TEQ (Mammal)
Comparison of Estimated Trajectories for Remediation Options for Be-7
Bearing Sediment (Ex. 5)
Lower Passaic River Restoration Project

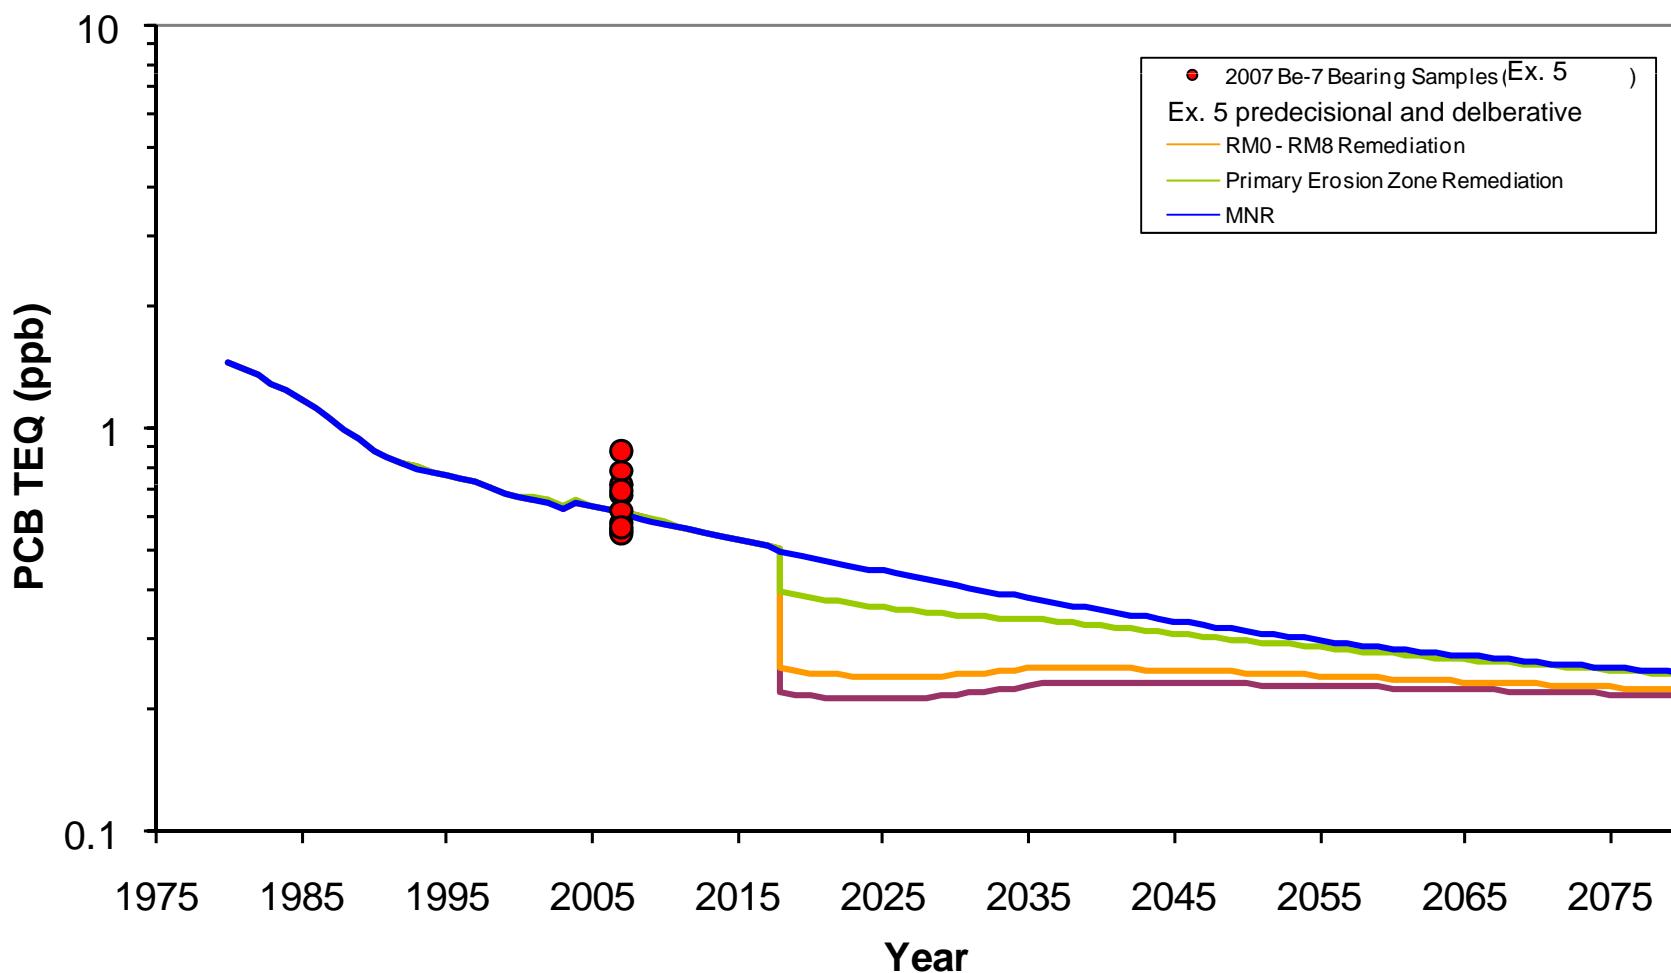
Figure 20-31

PCB TEQ (Fish)
Comparison of Estimated Trajectories for Remediation Options for Be-7
Bearing Sediment Ex. 5
Lower Passaic River Restoration Project

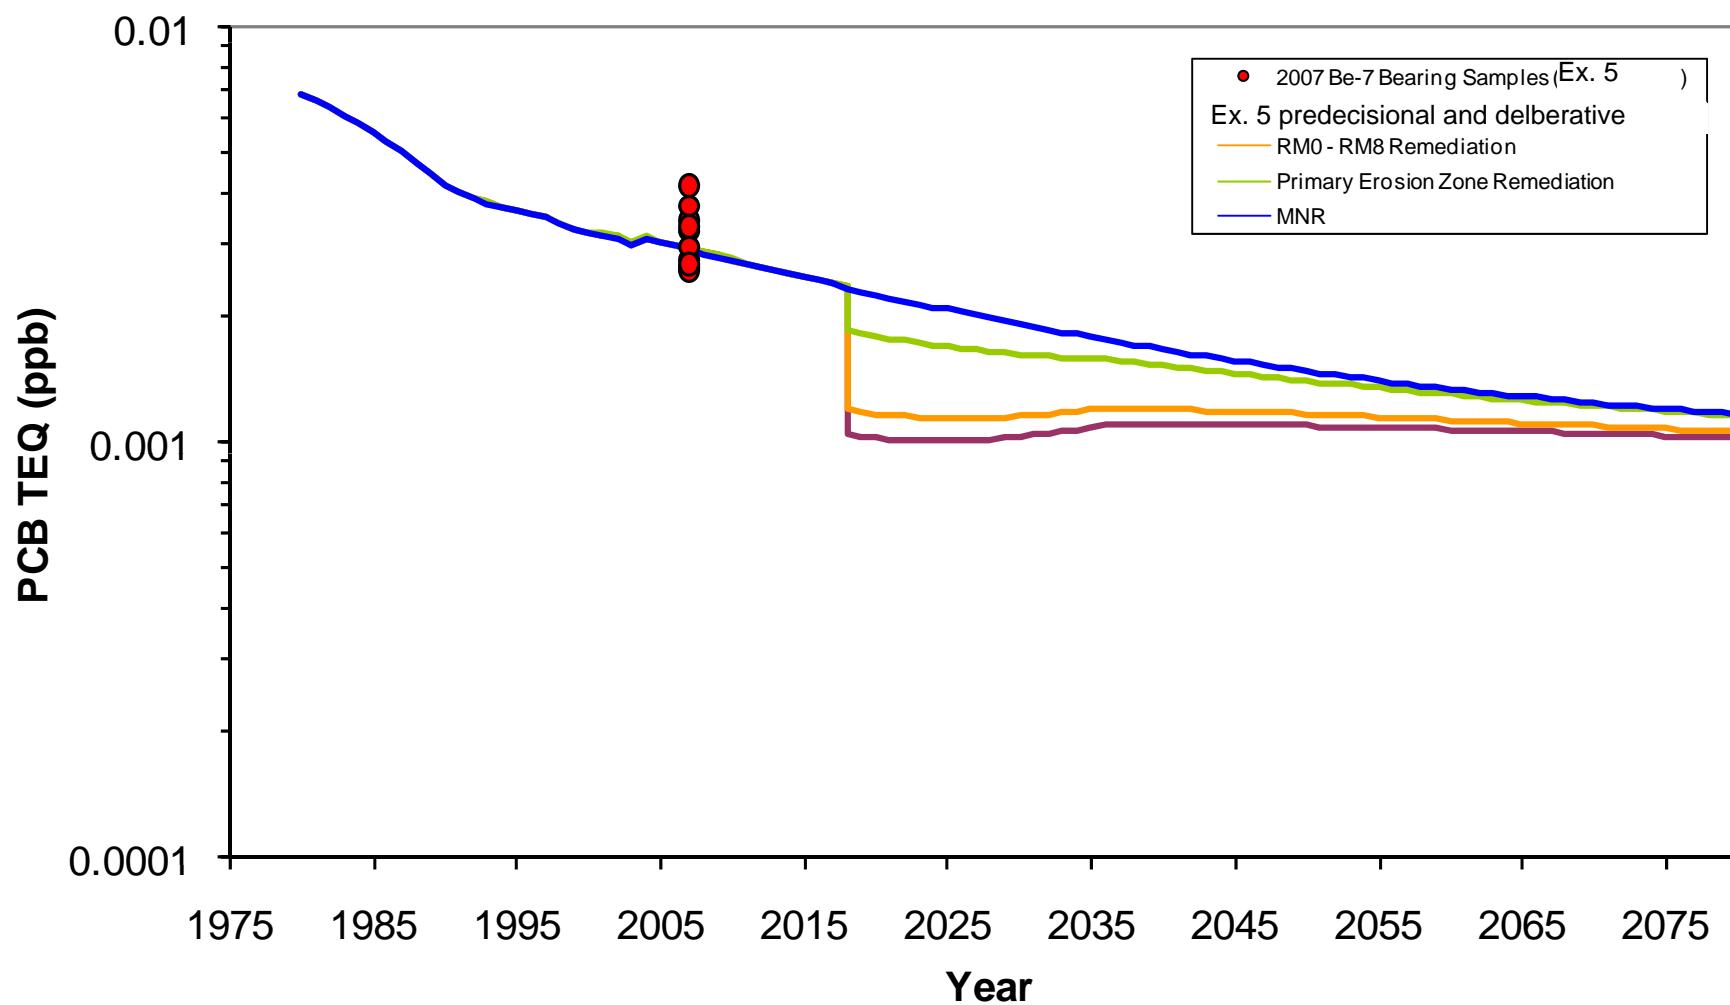
Figure 20-32

PCB TEQ (Bird)
Comparison of Estimated Trajectories for Remediation Options for Be-7
Bearing Sediment (Ex. 5)
Lower Passaic River Restoration Project

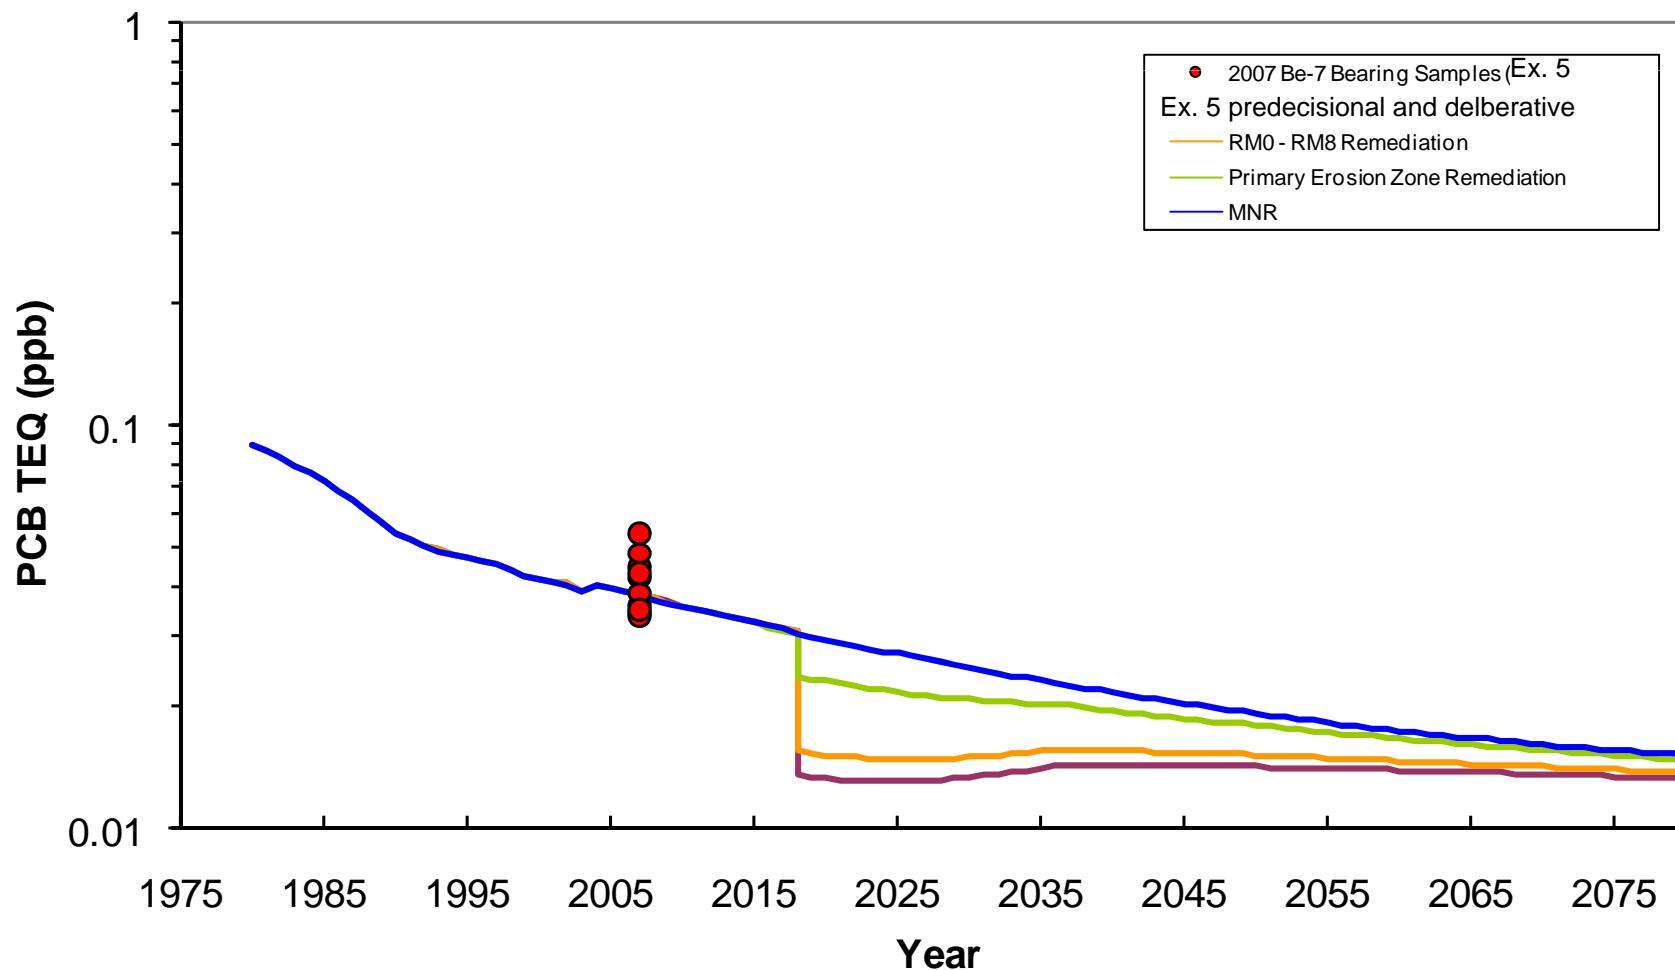
Figure 20-33

PCB TEQ (Mammal)
Comparison of Estimated Trajectories for Remediation Options for Be-7
Bearing Sediment (Ex. 5)
Lower Passaic River Restoration Project

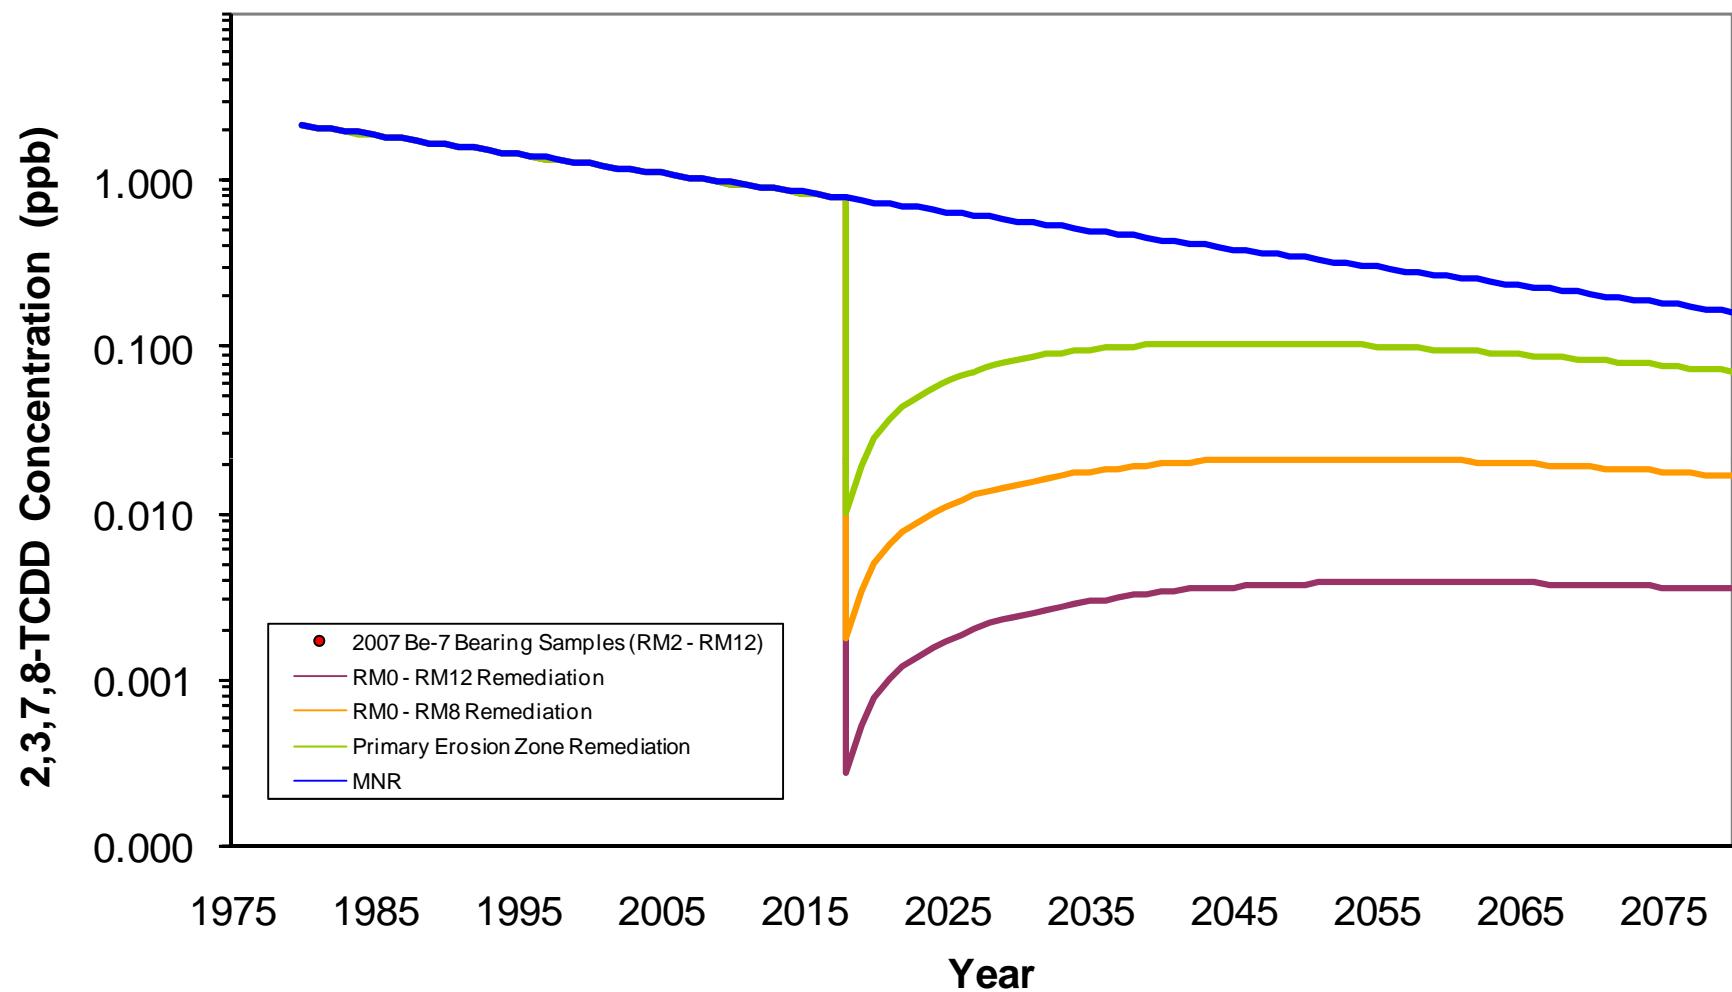
Figure 20-34

2,3,7,8-TCDD
Comparison of Estimated Trajectories for Remediation Options for 0-6 inch
Biologically Active Layer
Lower Passaic River Restoration Project

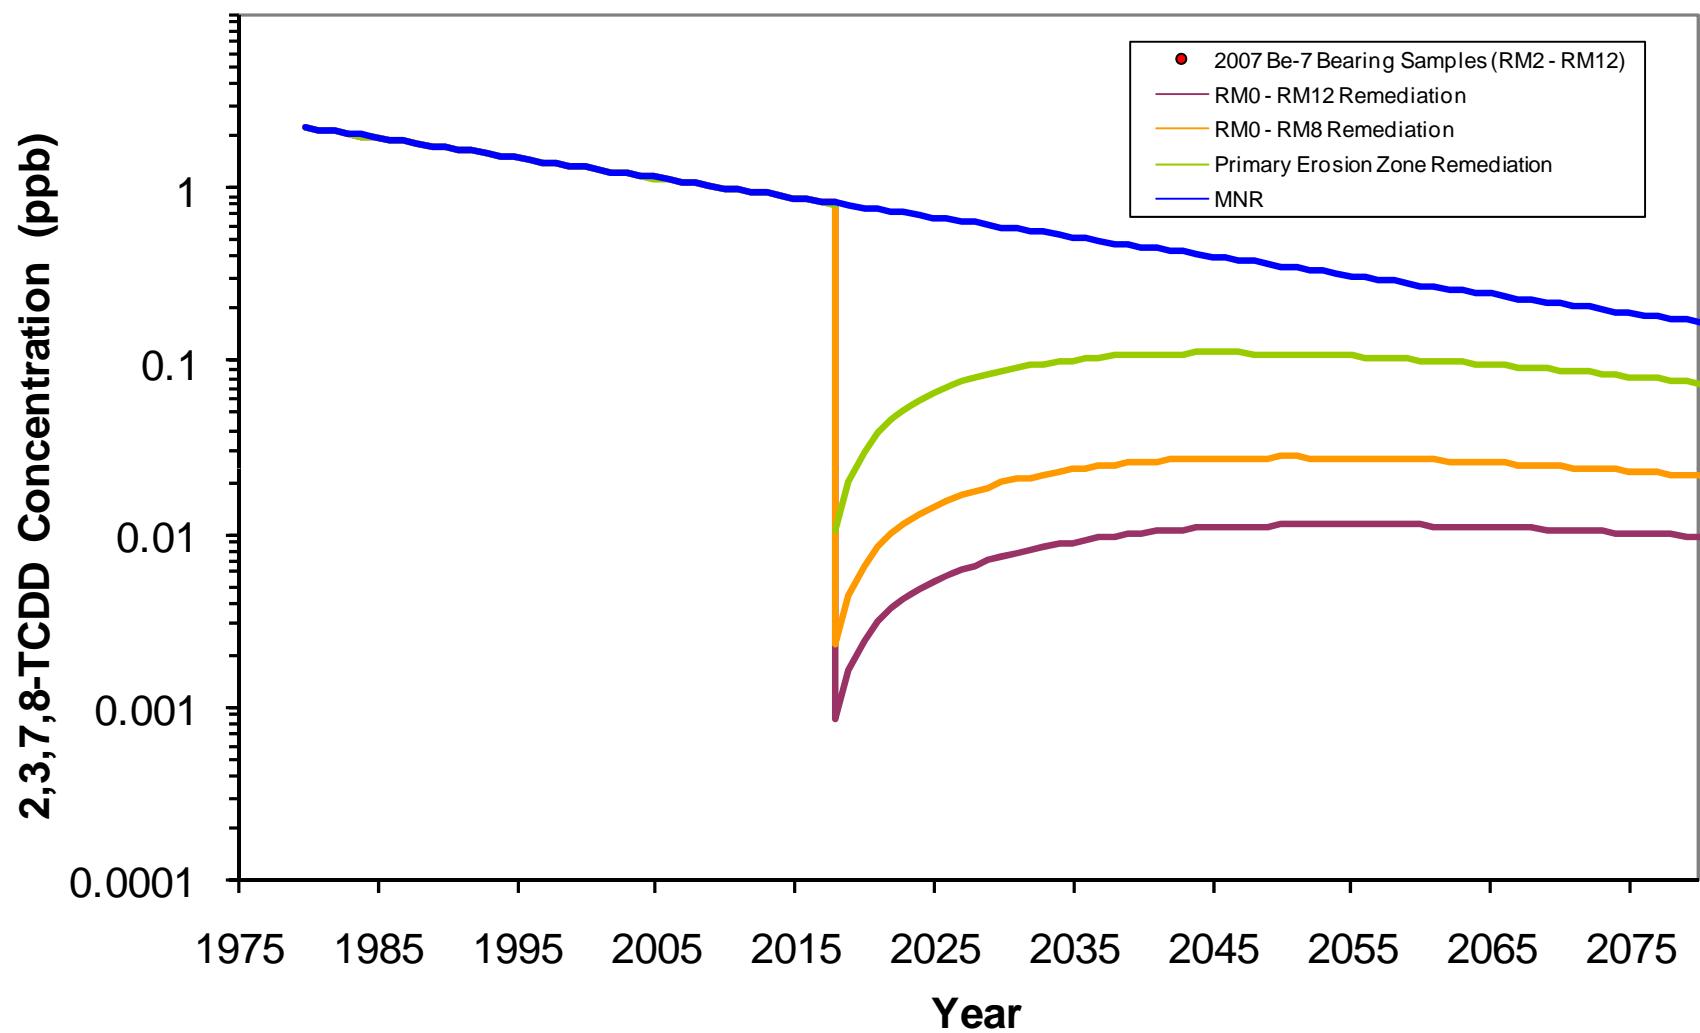
Figure 20-35

2,3,7,8-TCDD
Comparison of Estimated Trajectories for Remediation Options for 0-6 inch
Biologically Active Layer in Capped Regions
Lower Passaic River Restoration Project

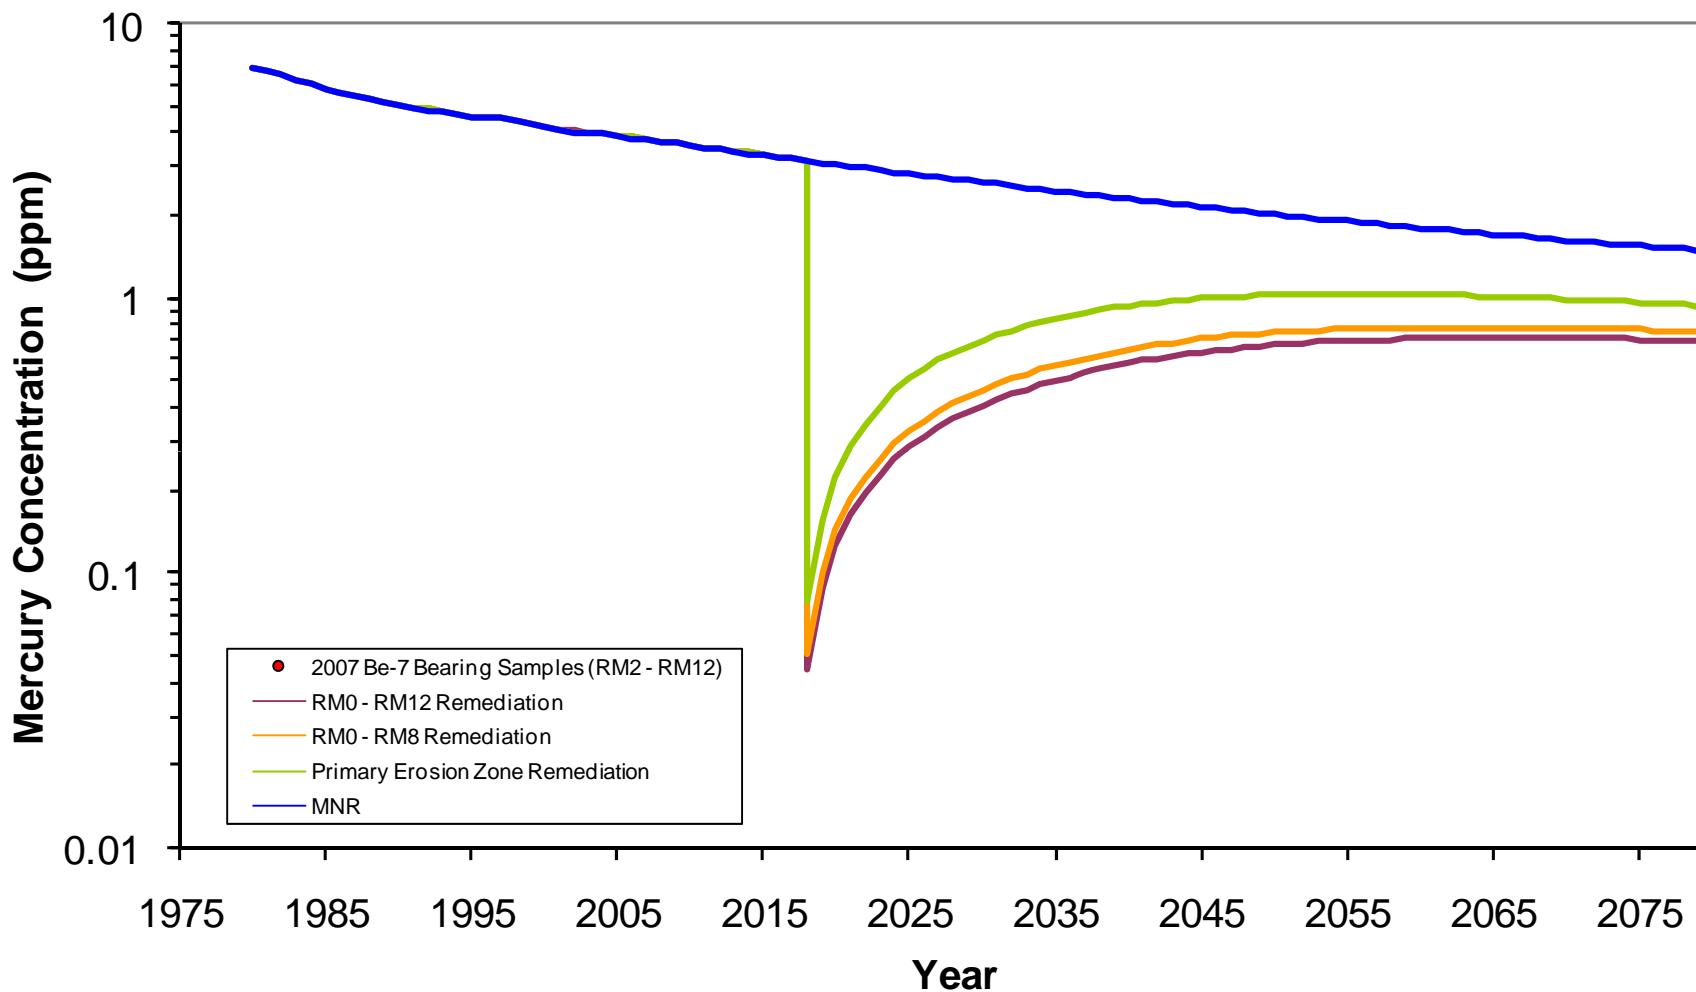
Figure 20-36

Mercury
Comparison of Estimated Trajectories for Remediation Options for 0-6 inch
Biologically Active Layer in Capped Regions
Lower Passaic River Restoration Project

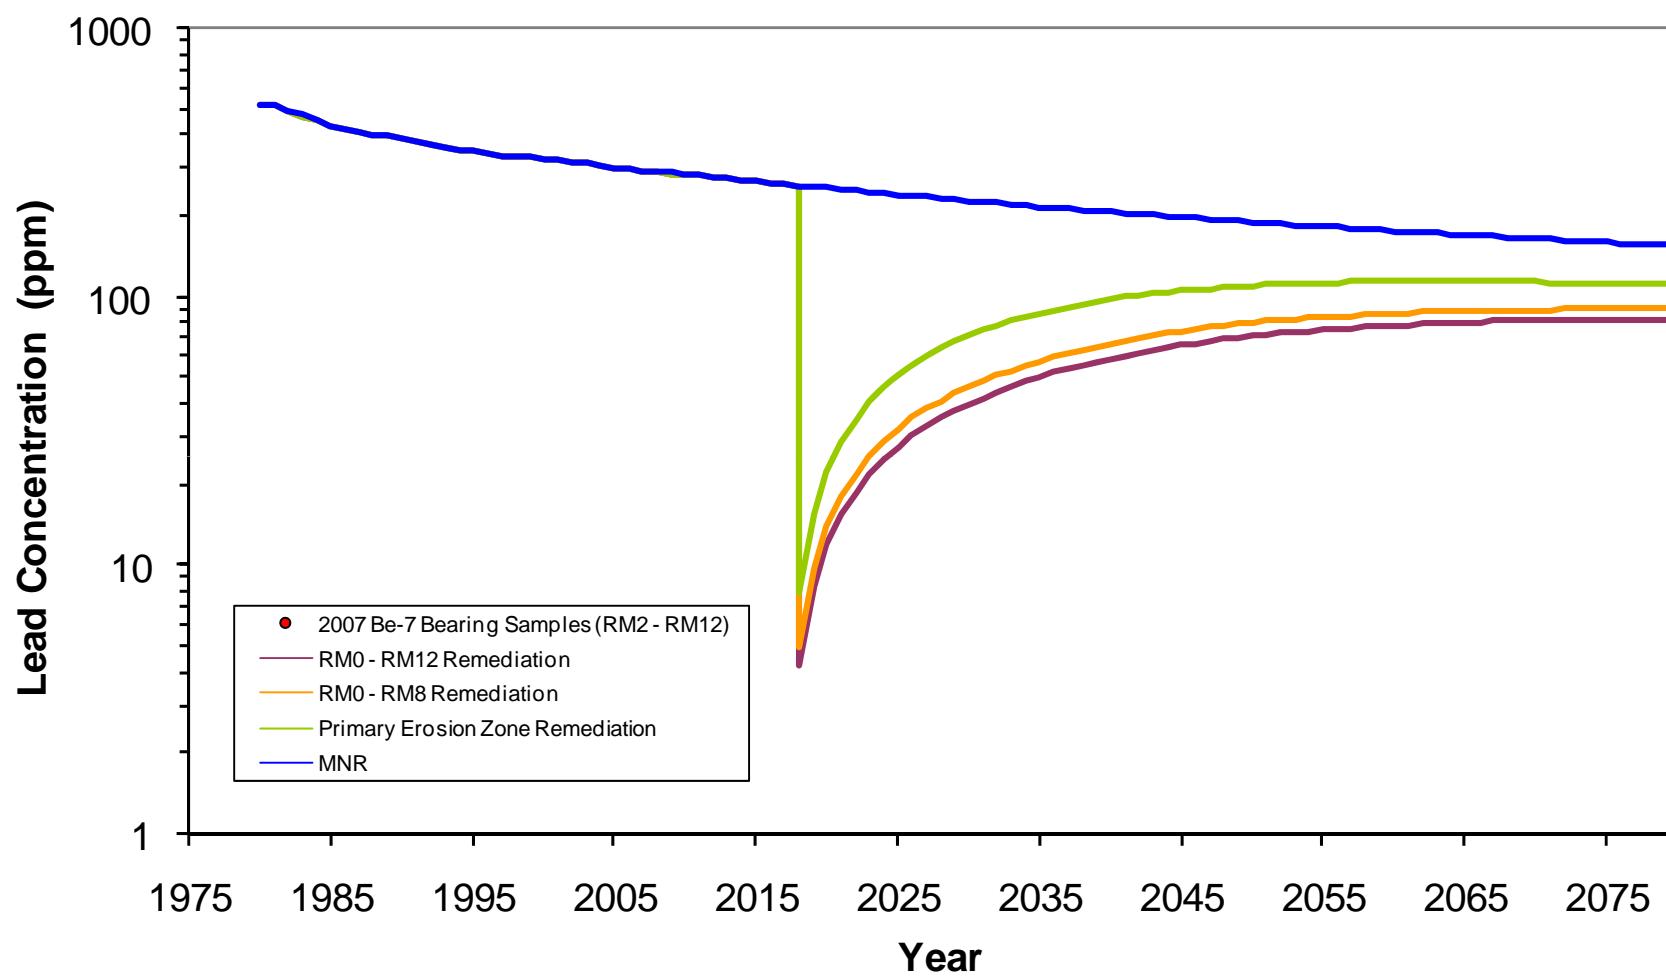
Figure 20-37

Lead
Comparison of Estimated Trajectories for Remediation Options for 0-6 inch
Biologically Active Layer in Capped Regions
Lower Passaic River Restoration Project

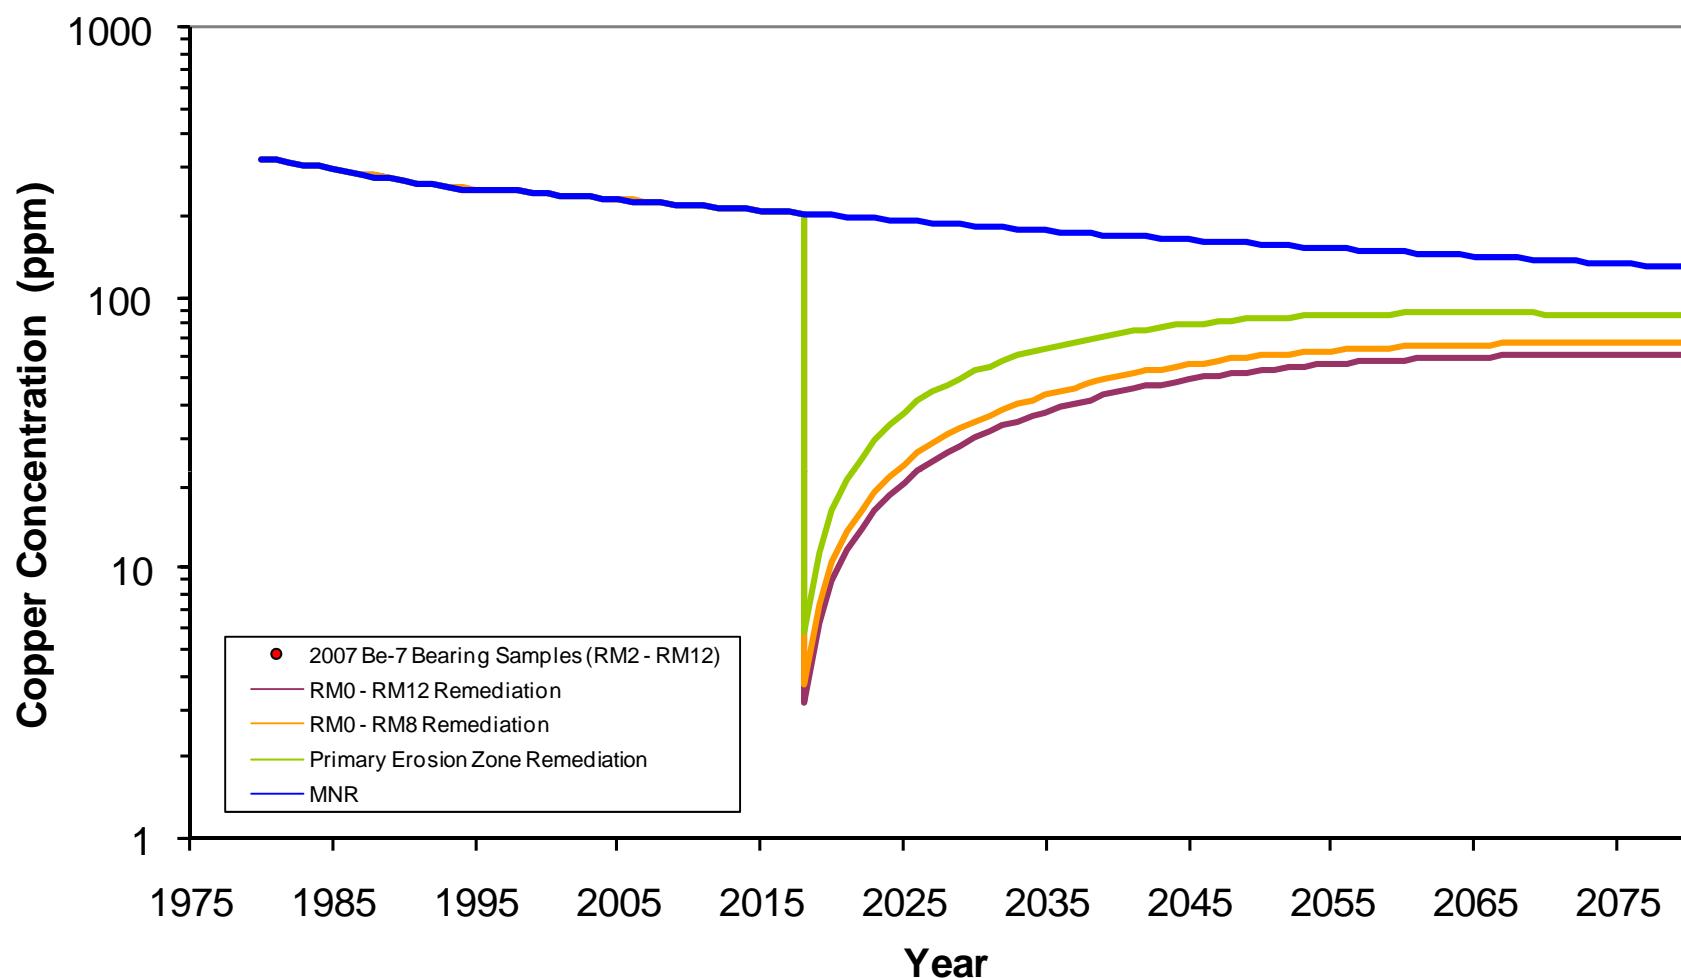
Figure 20-38

Copper
Comparison of Estimated Trajectories for Remediation Options for 0-6 inch
Biologically Active Layer in Capped Regions
Lower Passaic River Restoration Project

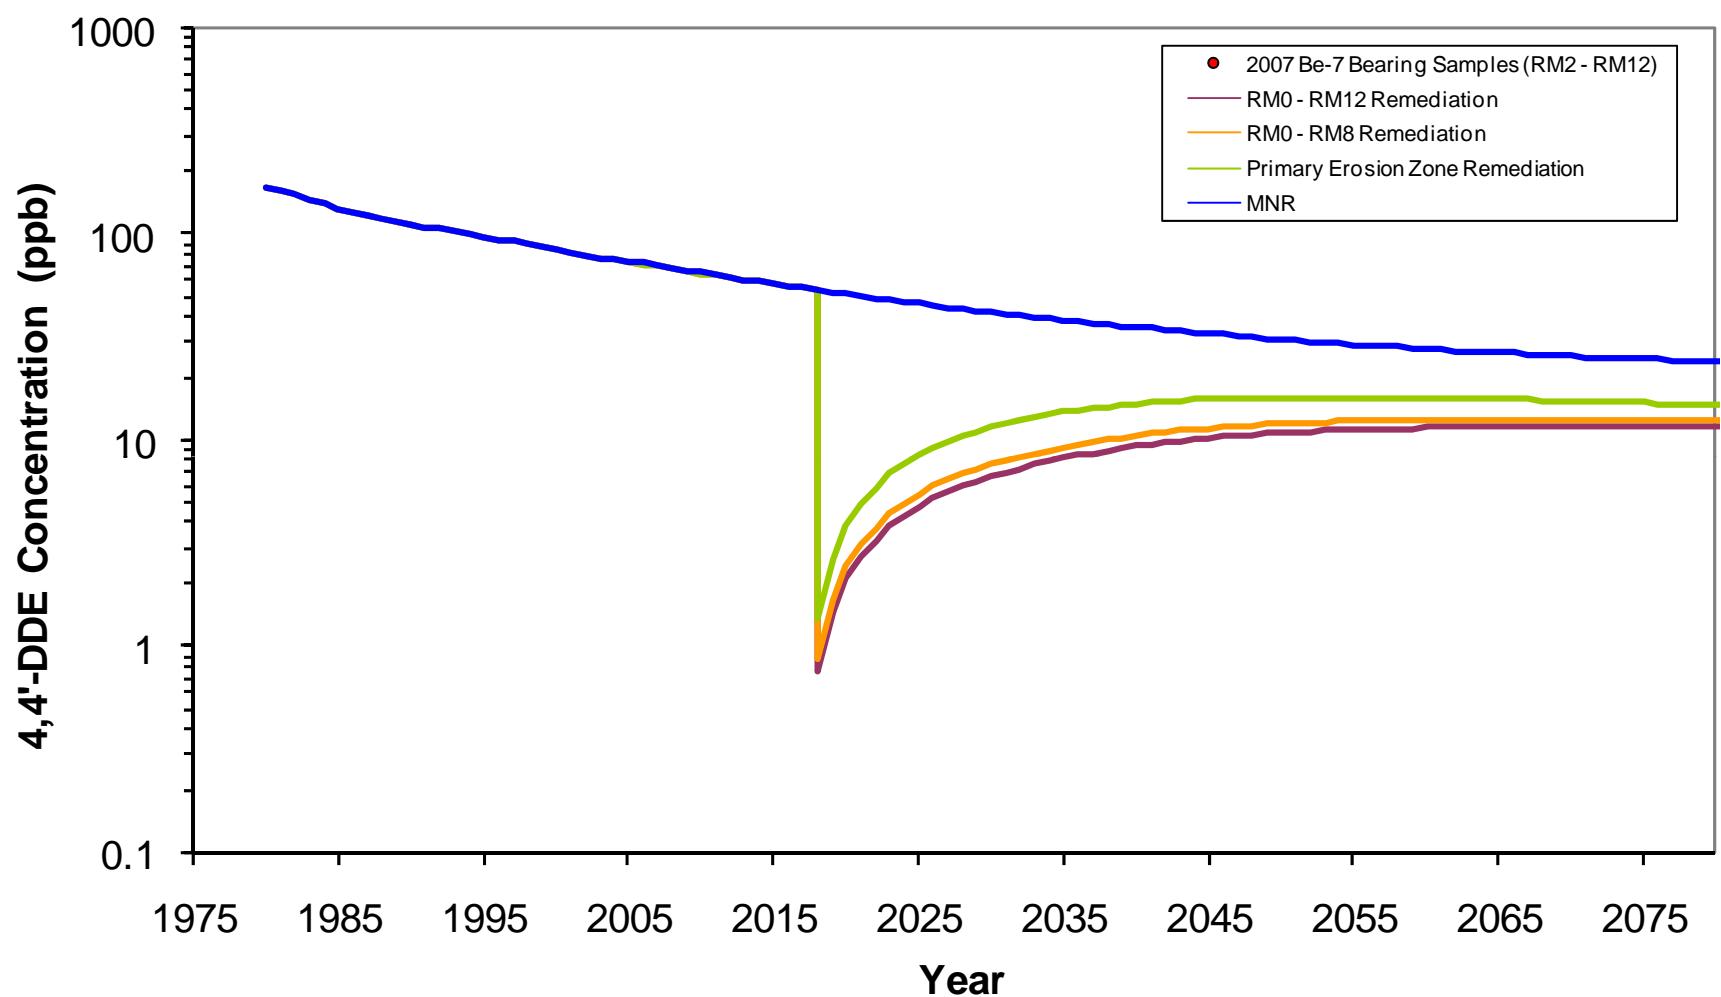
Figure 20-39

4,4'-DDE
Comparison of Estimated Trajectories for Remediation Options for 0-6 inch
Biologically Active Layer in Capped Regions
Lower Passaic River Restoration Project
